Oak Bluffs Harbor Oak Bluffs, Massachusetts

US Army Corps
of Engineers
New England Division

1. AGENCY USE ONLY (Leave blank)		2. REPORT DATE October 1991		3. REPORT TYPE AND DATES COVERED Reconnaissance Report
4. TITLE AND SUBTITLE Navigation Improvement Study, Oak Bluffs Harbor, Oak Bluffs, Massachusetts, Reconnaissance Report			5. FUNDING NUMBERS

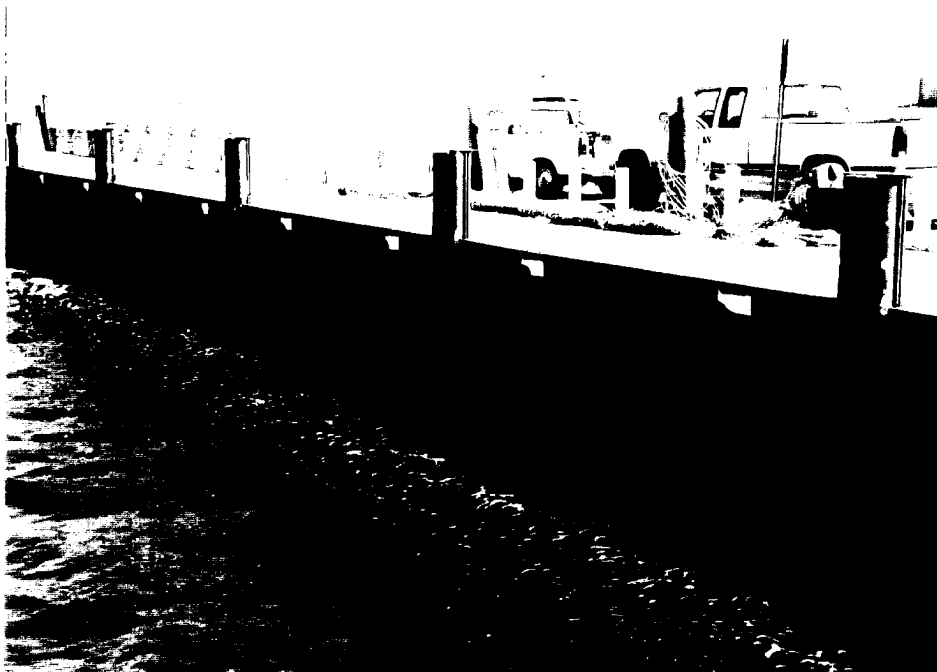
**Photographs
Oak Bluffs Harbor
Oak Bluffs, Massachusetts
Figure 3**

View of steel sheet pile bulkhead along south side of the harbor.

View of steel and timber sheet pile bulkhead along east side of the harbor.

The present harbor configuration is characterized by numerous bulkheads defining its perimeter (see Figure 3). These bulkheads consist of steel and timber sheet piling. The south side of the harbor contains a steel sheet-pile bulkhead constructed in 1985 along Lake Avenue which is in good condition. The east side of the harbor contains a timber sheet pile bulkhead approximately 500 feet long and a steel sheet pile bulkhead (600 feet long) constructed in 1970 along Circuit Avenue. There is also a
